4.3.7 FY96-02 Replacement

4.3.7.4 Unit Type FY96-02.2 Fy96-02 Replacement

Base Name: Holloman Air Force Base

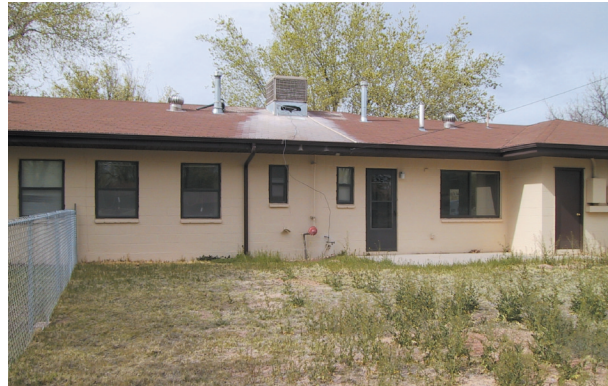
Rear elevation

- Exterior Wall Structure: concrete masonry unit; fair condition; concrete block walls do not provide proper insulating value for exterior walls.
- Exterior Wall Covering: painted; fair condition; poor/worn appearance; recurring maintenance issue.
- Foundation/Basement: slab on grade; fair condition; cracked and settled.
- Floor Structure: none; slab on grade.
- Windows - Frames: aluminum; good condition.
- Windows - Glazing: double; good condition; bedroom windows provide emergency egress.
- Windows - Screens: aluminum; good condition.
- Doors - Entry: metal; fair condition; flush door with many coats of painted; no peephole.
- Doors - Sliding Glass: none; not required.
- Doors - Storm/Screen: fiberglass; good condition.

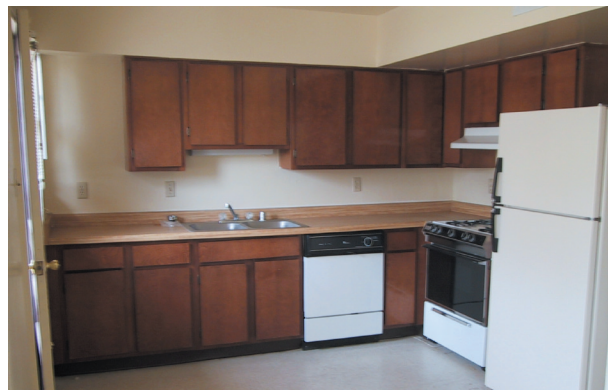
Kitchen

- Cabinets: wood; fair condition; worn finish; aged condition.
- Counter Tops: laminated; fair condition; butcher block pattern.
- Sink: stainless sink, double; fair condition; worn finish with scratches.
- Sink Fixtures: metal; poor condition; old fixture with some corrosion.
- Refrigerator: standard; fair condition; not clean.
- Range/Oven: gas; fair condition; scratched on top surface; not self cleaning.
- Vent Hood: exhaust fan; fair condition; slightly worn.
- Dishwasher: standard; fair condition; worn interior.
- Garbage Disposal: standard; fair condition; slightly worn.
- Flooring: vinyl composite tile; fair condition; worn surfaces.
- Walls: gypsum wall board; fair condition.
- Wall Finish: painted; fair condition.

- Ceilings: gypsum wall board; fair condition.
- Ceiling Finish: painted; fair condition; yellowish color.
- Interior Hardware: aluminum; fair condition; worn finish.

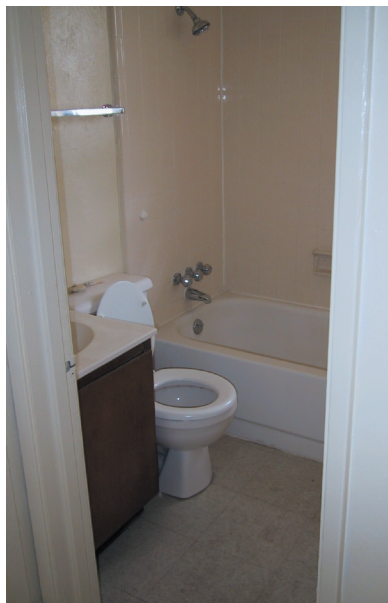
Bathroom 1

- Cabinets: wood; poor condition; worn finish exterior and interior of cabinet.
- Counters: cultured marble; good condition.
- Sink: cultured marble; good condition.
- Fixture Hardware: chrome; fair condition; slight corroded.
- Toilet: porcelain; fair condition; older but functional.
- Tub/Shower: combination; fair condition; no slip resistance in tub; dated ceramic tile tub surround.
- Flooring: vinyl composite tile; fair condition; worn finish.
- Walls: gypsum wall board; fair condition.
- Wall Finish: painted; poor condition; peeling paint.
- Ceilings: gypsum wall board; fair condition.
- Ceiling Finish: painted; fair condition.
- Ventilation: none; exhaust fan required.
- Interior Hardware: metal; fair condition; worn finish.
